Dr. E. L. Trudeau Building
118 Main Street
Saranac Lake NY

Historic Building Evaluation
Structural Conditions Requiring Remediation
Gordon + Gordon Architecture, LLC
June 24, 2018

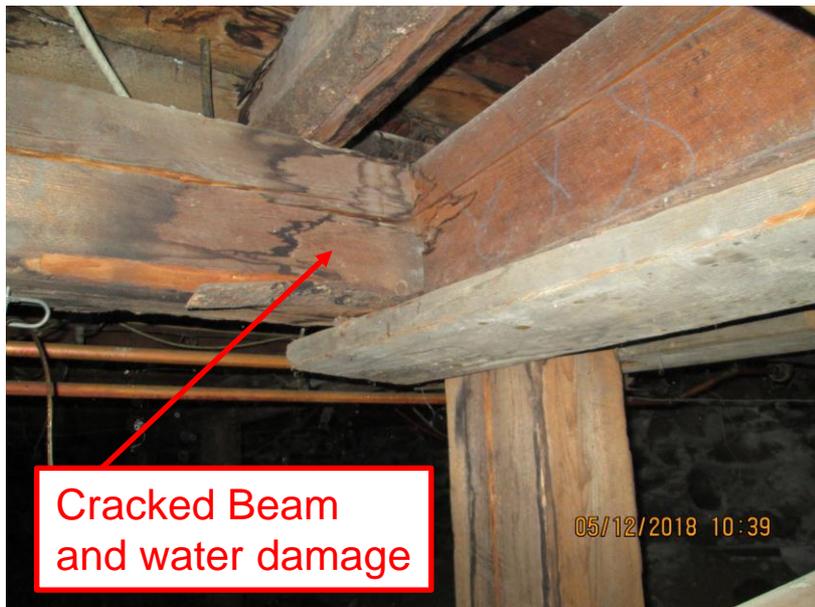
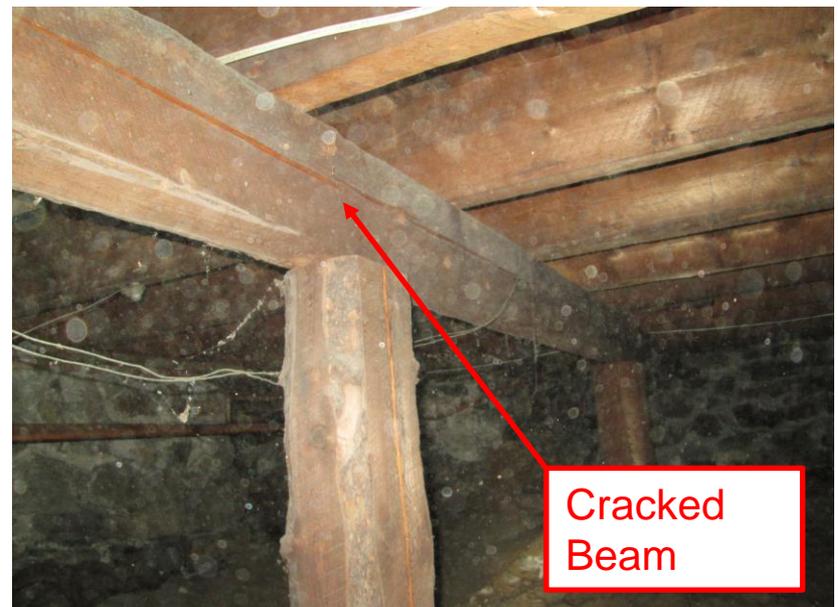
Longitudinal cracking was observed along the length of the main north – south floor beam and an east – west floor beam beneath the stairs. Some deterioration of columns and footings supporting these floor beams was also found. These conditions will need to be repaired or replaced.

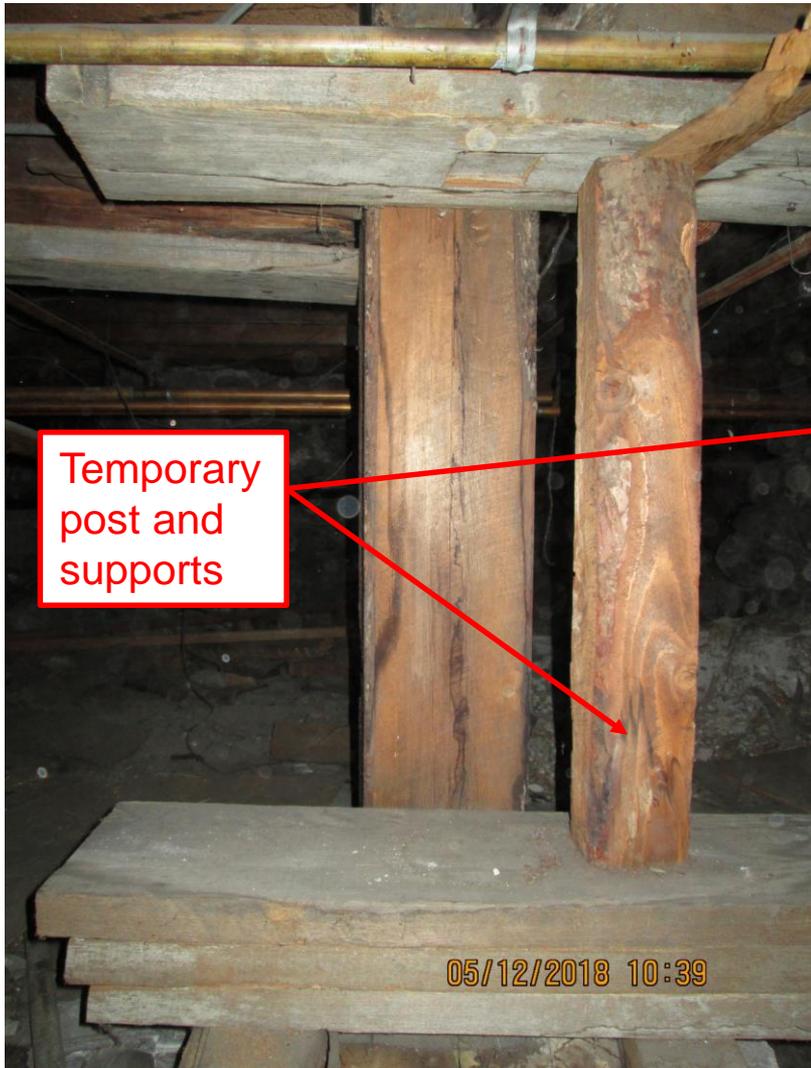
Some work has been done in the past to “shore-up” elements of the structural floor system by the addition of temporary posts and supports. No remedial repairs to the original structure were observed.

Temporary post and supports

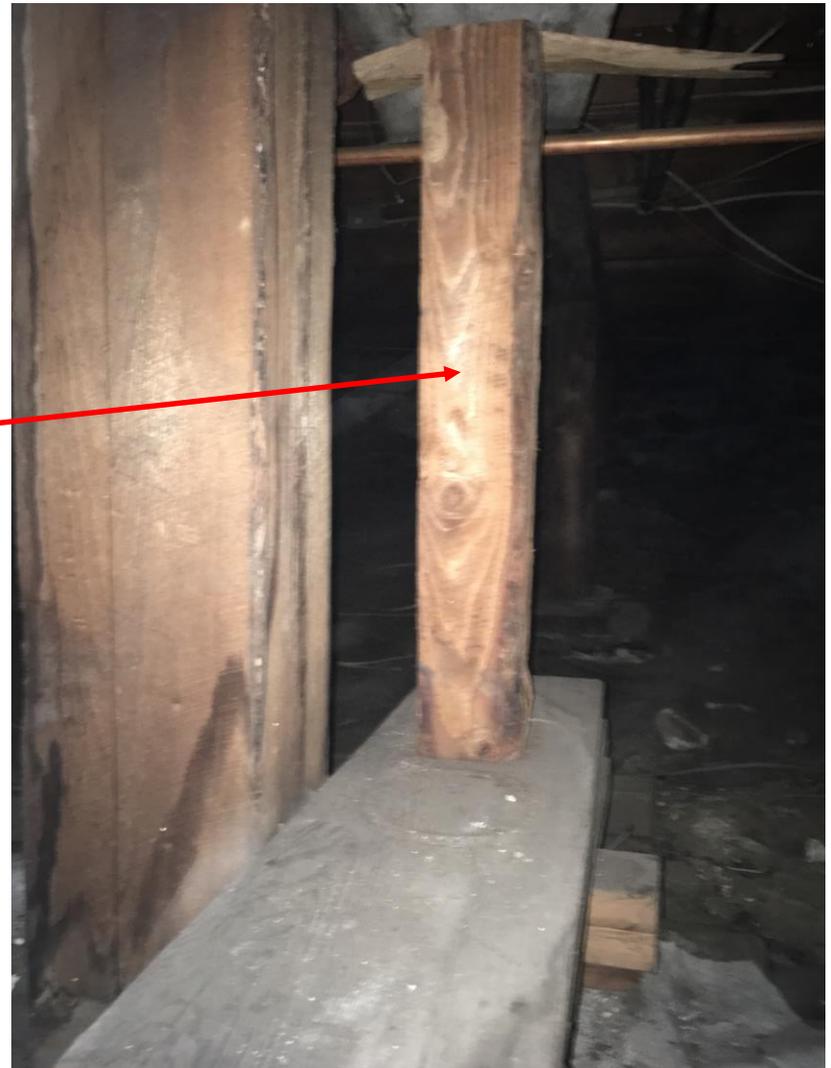
There is evidence of sagging of the first floor structure near the building entrance and main historic stair that appear to be related to these cracked beams and deteriorated columns and footings. Repair or replacement will be necessary.

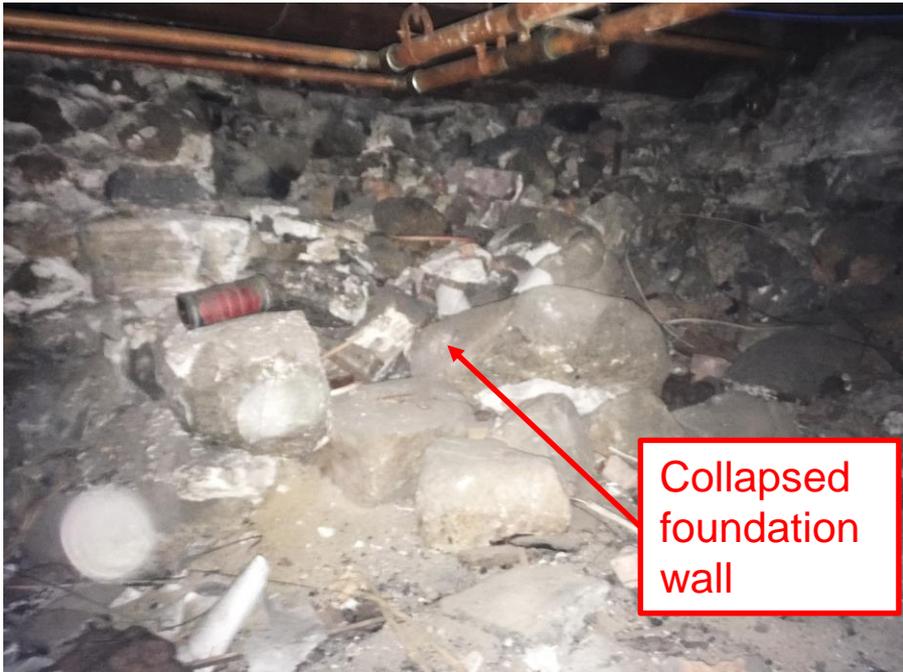
Significant damage was also found in a foundation timber below the Main Street entrance door that appears to be caused by water penetration due to poor external drainage. Portions of the stone foundation are also damaged and have collapsed at this location. Substantial structural repairs or replacement will be required.

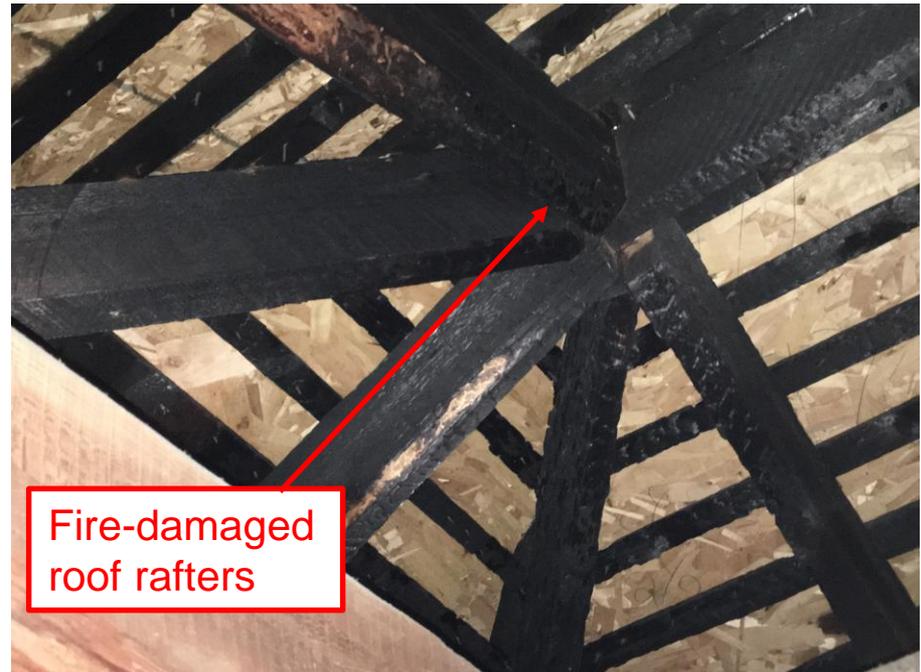
In the attic, evidence was found of a past fire that damaged some of the primary roof rafters. Subsequently, the roof sheathing was replaced with oriented strand board (OSB) placed over the original skip sheathing (the original roof was cedar shingles, which are typically installed over skip sheathing).

There is no evidence of attempts to reinforce or replace the fire-damaged rafters. Field measurements of these rafters demonstrate significant loss of the rafter mass and their structural integrity must be assessed to determine required repairs.

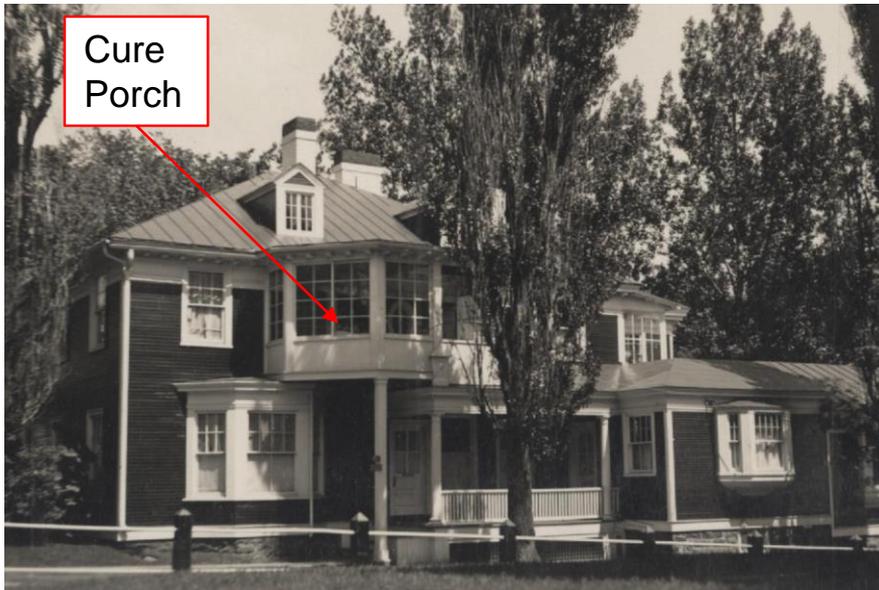
This 1931 photograph shows the addition of a second floor “cure porch” that was appended to the west elevation of the original structure, probably during Dr. Trudeau’s residence in the home.

Historic Saranac Lake is investigating the potential to restore the building to the condition shown in this photograph by rehabilitating historic fabric and removing later additions that are not compatible with the historic building.

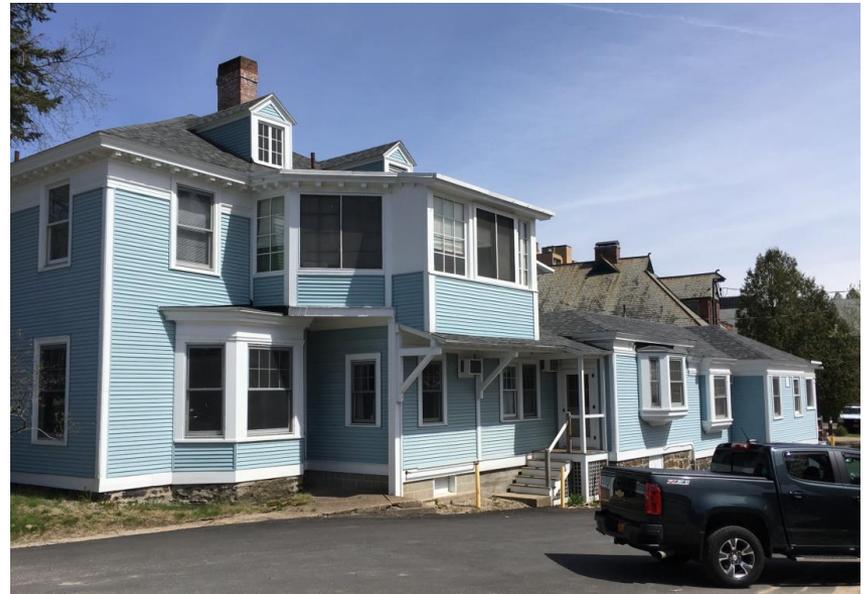
This contemporary photograph shows that later, non-historic additions were made to extend the west and south sides of the “cure porch” and the south side was enclosed to create unheated space.

This space was used by the medical practice for storage of heavy file cabinets. The condition of the floor and roof structure requires an engineering assessment. The cantilevered bay needs to be assessed to determine if removal is feasible.
