Dr. Edward Livingston Trudeau Building

118 Main Street, Saranac Lake, NY

Building Systems Report

June 24, 2018

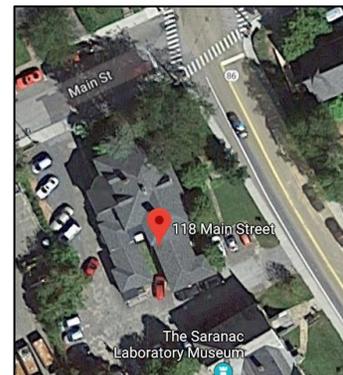
The building is located at the intersection of Main and Church Streets on a lot of 0.38 acres contiguous to the Saranac Laboratory Museum. The property is classified as Commercial Professional and is in the E-3 Zoning District. The site has landscaping in fair condition on the north and east sides; water collects against the northeast corner of the building, damaging the structure. The site is primarily asphalt-paved parking on the south and west sides. Two storm drains are located at a low point in the southwest corner of the site. There is a brick sidewalk sloping up to the entry door on Main Street. There are also building entries on the east and south sides.

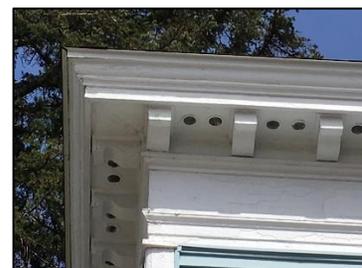
The exterior finish of the building is vinyl siding, probably applied over the original wood siding, although this could not be verified. Trim around openings, the water table, and the roof cornice is painted wood in fair condition; some repairs and repainting are required. The roof has a painted wood cornice with Italianate brackets, a simple

frieze and architrave. Soffit vents have been installed to ventilate the attic.

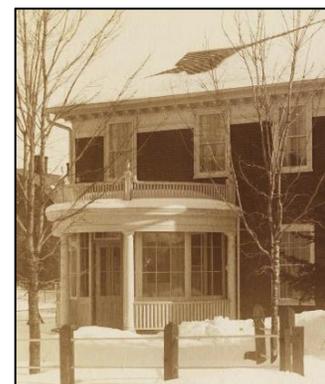
The original entrance to the building on Main Street was a semi-circular portico with a balustrade and what appear to have been glazed window panels set back from the railing.

This historic entrance was removed and replaced with a gable roof with enclosed sides and an open front. The historic door and “ornate large-scale sidelights of clear leaded glass in an oval pattern”, described in the nomination for the National Register of Historic Places, have been replaced with contemporary components.

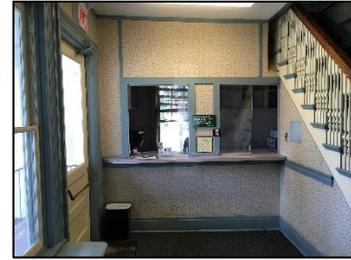
The entrance from Main Street is to a foyer with an original open wood stair to the second floor. Stair treads and risers are carpeted. The configuration and materials of the foyer have been substantially altered by the insertion of a reception desk and window that were used by the medical practice that previously occupied the building.

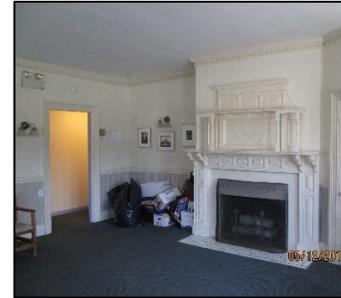
West of the entry foyer is a large room with what appear to be original wood and/or plaster trim and moldings. There is a large ornate fireplace on the south wall of the room. Some non-historic changes have been made to this room such as the addition of a room air conditioner and a toilet room. This room has good potential for restoration.

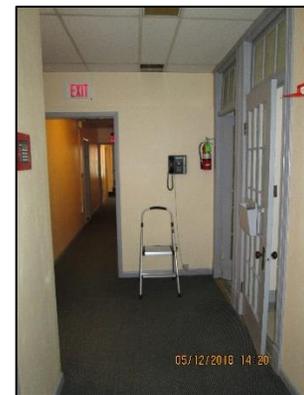
The remaining rooms on the first floor have been substantially modified over time. There are both plaster and gypsum board walls and ceilings. Some rooms have acoustic ceiling tiles. There is a utility chase in the hallway ceiling running from north to south. Most floors are carpeted or have composition flooring materials. Some window and door trim is probably original but many of the changes made over time used contemporary finish materials.

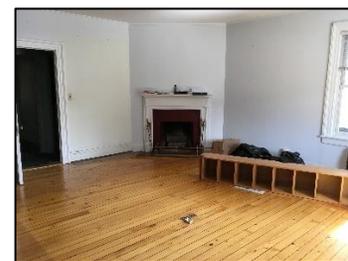
Most of the second floor rooms have been substantially altered to serve the needs of the medical practice. There are both plaster and gypsum board walls and ceilings. Most rooms have carpeted floors, with wood floors in some rooms. Some kitchens and bathrooms are in what appear to be the original locations; others have been added. Two rooms have fireplaces that appear to be historic and are believed to be non-functioning.

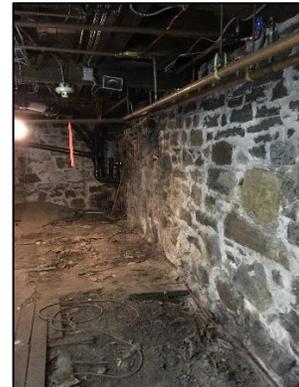
There is a standing-height cellar under portions of the original building; the remaining portions are a crawl space. The original walls are field stone, about two-feet in thickness. The floor is a combination of dirt, concrete, and wood. Electrical, mechanical, and plumbing utilities of a range of vintages are distributed throughout the spaces. Later additions to the building used concrete or concrete masonry unit construction for foundation walls. The cellars are only accessible through exterior hatches.

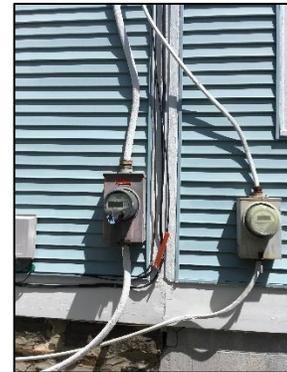
Electrical service is provided overhead from a power pole located behind the Saranac Laboratory Museum to a service entrance with two electrical meters on the south of the building. There is a main electrical panel in the cellar at this location and four other subpanels were located throughout the building. The wiring has been installed over time using a variety of materials. There are some code deficiencies that require corrections.

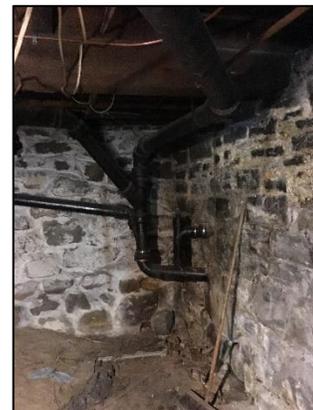
A single water service entrance and meter was found in the cellar beneath the original building. Reportedly, municipal water service lines are located beneath the paving on the west side of the building. There is an 80-gallon electric water heater located adjacent to the heating system boilers.
