RE: Hazardous Materials Survey Report – Pre-Renovation
Asbestos, Lead-Based Paint and Polychlorinated Biphenyls (PCB)
Trudeau Building
118 Main Street
Saranac Lake, New York 12983
Ambient Project Number: 180627AA

HAZARDOUS MATERIALS SURVEY

Asbestos, Lead-Based Paint and PCB Caulk

*Trudeau Building
118 Main Street
Saranac Lake, New York 12983*

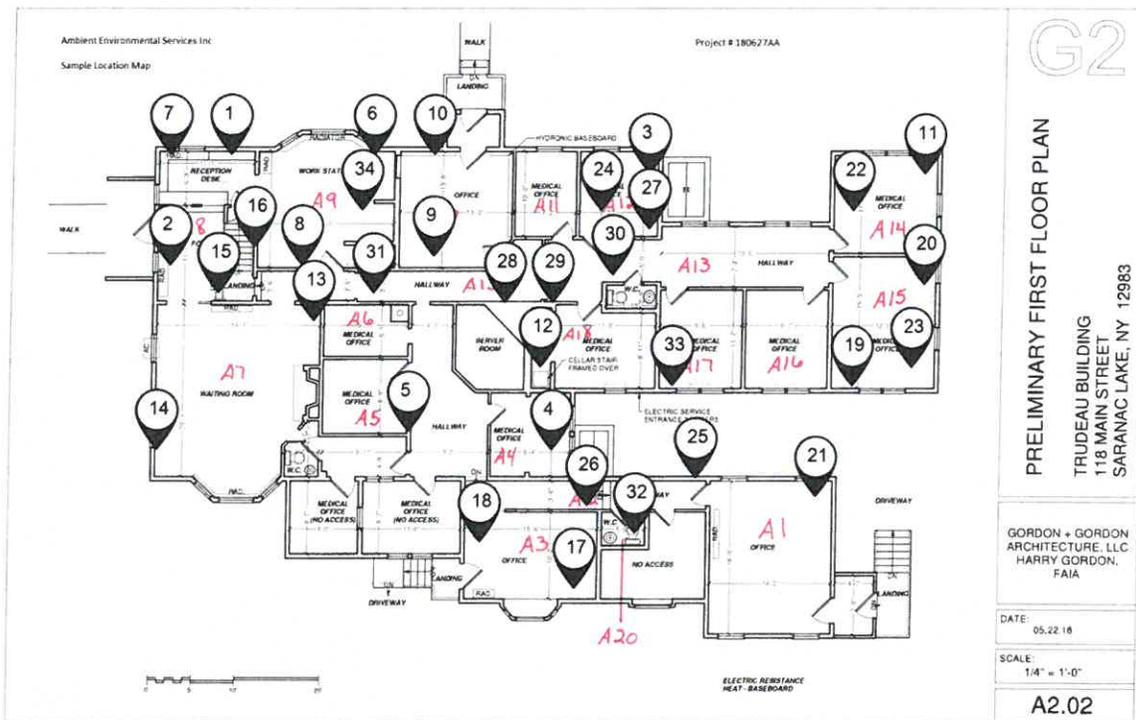
All Sample Locations for First Floor

Map ID	Sample ID	Section Name	Space Name	Material	Lab Result
32	12-01	First Floor	A20	White Speckled Sheet Flooring	NAD
32	13-02	First Floor	A20	Tan Sheet Flooring Adhesive	NAD
33	18-01	First Floor	A8	White Gypsum Wallboard	NAD
33	19-01	First Floor	A17	White Gypsum Wallboard Joint Compound	0.5% Chrysotile
1	28-01	First Floor	A8	Tan Sheet Flooring Burlap Backed	NAD
2	28-02	First Floor	A8	Tan Sheet Flooring Burlap Backed	NAD
7	29-01	First Floor	A8	Pink Swirl Wallpaper	NAD

Map ID	Sample ID	Section Name	Space Name	Material	Lab Result
6	29-02	First Floor	A9	Pink Swirl Wallpaper	NAD
7	30-01	First Floor	A8	Pink Swirl Wallpaper Adhesive	NAD
2	31-01	First Floor	A8	Black Floor Moisture Barrier	NAD
1	31-02	First Floor	A8	Black Floor Moisture Barrier	NAD
1	32-02	First Floor	A8	4"X4" Plum Cove Base	NAD
8	32-02	First Floor	A9	4"X4" Plum Cove Base	NAD
4	33-01	First Floor	A4	Yellow Cove Adhesive	NAD
5	33-02	First Floor	A5	Yellow Cove Adhesive	NAD
4	34-01	First Floor	A4	4"X4" Tan Cove Base	NAD
5	34-02	First Floor	A5	4"X4" Tan Cove Base	NAD
3	35-01	First Floor	A4	Black Sealant, Sink Undercoating	5.8% Chrysotile
4	35-02	First Floor	A4	Black Sealant, Sink Undercoating	NA/PS
1	36-01	First Floor	A8	Tan Cove Adhesive	NAD
8	36-02	First Floor	A9	Tan Cove Adhesive	NAD
9	37-01	First Floor	A10	Tan Woven Wallpaper	NAD
10	37-02	First Floor	A10	Tan Woven Wallpaper	NAD
10	38-01	First Floor	A10	Yellow (Woven) Wallpaper Adhesive	Insufficient Material For Preparation

Map ID	Sample ID	Section Name	Space Name	Material	Lab Result
20	48-02	First Floor	A15	Small Stone Floor, Sheet Vinyl Paper Backing	NAD
21	49-01	First Floor	A1	Black Floor Moisture Barrier	NAD
21	49-02	First Floor	A1	Black Floor Moisture Barrier	NAD
23	50-01	First Floor	A15	1'X1' White Pinhole Ceiling Tile, Splined	NAD
22	50-02	First Floor	A14	1'X1' White Pinhole Ceiling Tile, Splined	NAD
24	51-01	First Floor	A12	2'x2' White Wormtrack Ceiling Tile, Lay In	NAD
24	51-02	First Floor	A12	2'x2' White Wormtrack Ceiling Tile, Lay In	NAD
21	52-01	First Floor	A1	Light Tan Sheet Flooring Burlap Backed	NAD
21	52-02	First Floor	A1	Light Tan Sheet Flooring Burlap Backed	NAD
23	53-01	First Floor	A15	1'X1' Tan (Pinhole) Ceiling Tile Adhesive	Anthophyllite Trace
22	53-02	First Floor	A14	1'X1' Tan (Pinhole) Ceiling Tile Adhesive	Anthophyllite Trace
25	54-01	First Floor	A2	4'x8' White Grooved Gypsum Wallboard	NAD
26	54-02	First Floor	A2	4'x8' White Grooved Gypsum Wallboard	NAD

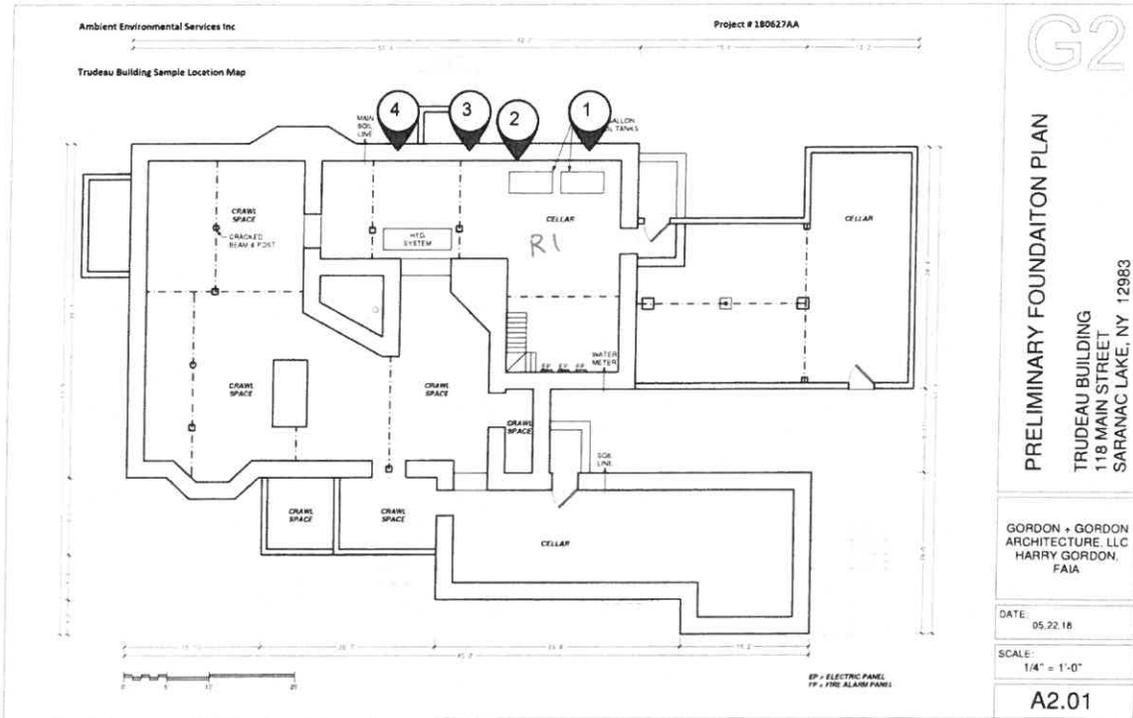
All Sample Locations for Basement

Map ID	Sample ID	Section Name	Space Name	Material	Lab Result
1	57-01	Basement	R1	Gray Pipe Insulation, Corrugated	44.4% Chrysotile
2	57-02	Basement	R1	Gray Pipe Insulation, Corrugated	NA/PS
1	57-03	Basement	R1	Gray Pipe Insulation, Corrugated	NA/PS
3	58-01	Basement	R1	Gray Stone Masonry Mortar	NAD
4	58-02	Basement	R1	Gray Stone Masonry Mortar	NAD

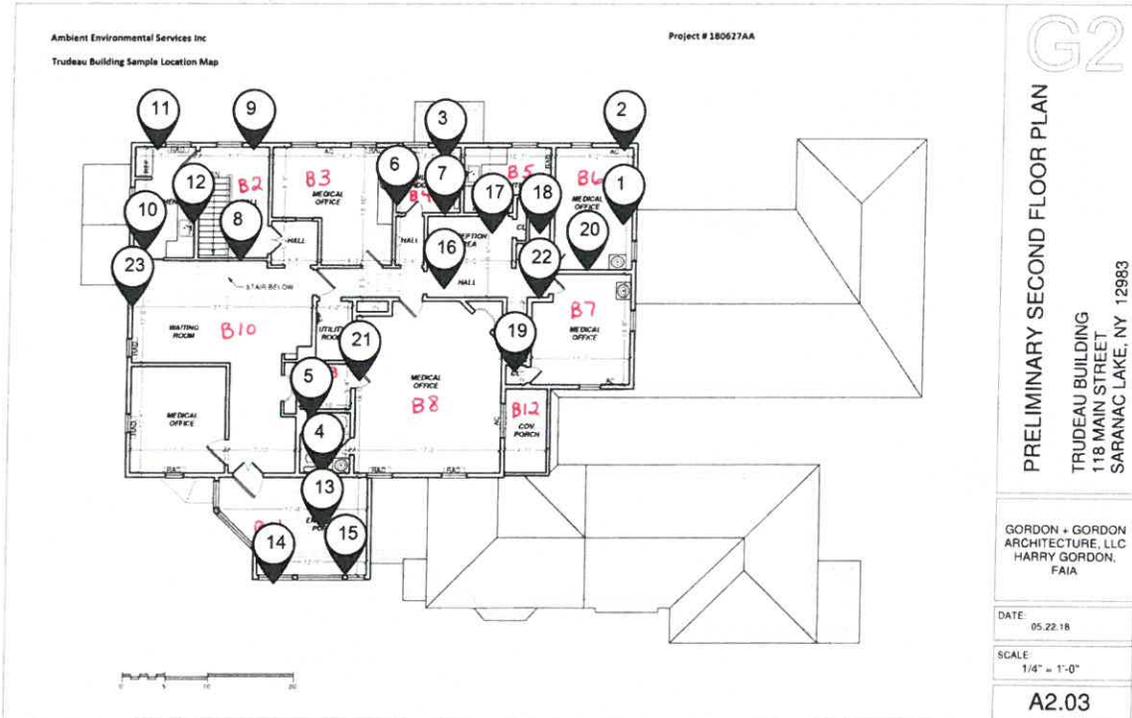
All Sample Locations for Second Floor

Map ID	Sample ID	Section Name	Space Name	Material	Lab Result
21	01-01	Second Floor	B8	White Acoustical Plaster, Ceilings	NAD
19	01-02	Second Floor	B7	White Acoustical Plaster, Ceilings	NAD
20	01-03	Second Floor	B6	White Acoustical Plaster, Ceilings	NAD
22	02-01	Second Floor	B6	White Acoustical Plaster, Walls	NAD
23	02-02	Second Floor	B10	White Acoustical Plaster, Walls	NAD
22	02-03	Second Floor	B13	White Acoustical Plaster, Walls	NAD
16	03-01	Second Floor	B13	2'x4' White Worm Track Ceiling Tile, Lay In	NAD
17	03-02	Second Floor	B13	2'x4' White Worm Track Ceiling Tile, Lay In	NAD
3	04-01	Second Floor	B4	Gray Cove Base	NAD
7	04-02	Second Floor	B4	Gray Cove Base	NAD
3	05-01	Second Floor	B4	White Cove Adhesive	NAD
3	05-02	Second Floor	B4	White Cove Adhesive	NAD

Map ID	Sample ID	Section Name	Space Name	Material	Lab Result
1	06-01	Second Floor	B6	Blue Floral Wallpaper	NAD
2	06-02	Second Floor	B6	Blue Floral Wallpaper	NAD
1	07-01	Second Floor	B6	Blue Floral Wallpaper Adhesive	NAD
2	07-02	Second Floor	B6	Blue Floral Wallpaper Adhesive	NAD
5	08-01	Second Floor	B7	4"X4" Tan Tile Adhesive	NAD
5	08-02	Second Floor	B7	4"X4" Tan Tile Adhesive	NAD
7	10-01	Second Floor	B4	Tan Tree Wallpaper	NAD
7	10-02	Second Floor	B4	Tan Tree Wallpaper	NAD
7	11-01	Second Floor	B4	Tan Tree Wallpaper Adhesive	NAD
7	11-02	Second Floor	B4	Tan Tree Wallpaper Adhesive	NAD
3	12-02	Second Floor	B4	White Speckled Sheet Flooring	NAD
3	13-01	Second Floor	B4	Tan Sheet Flooring Adhesive	NAD
3	14-01	Second Floor	B4	Green Woven Wallpaper	NAD
3	14-02	Second Floor	B4	Green Woven Wallpaper	NAD
3	15-01	Second Floor	B4	Green Woven Wallpaper Adhesive	NAD
6	15-02	Second Floor	B4	Green Woven Wallpaper Adhesive	NAD

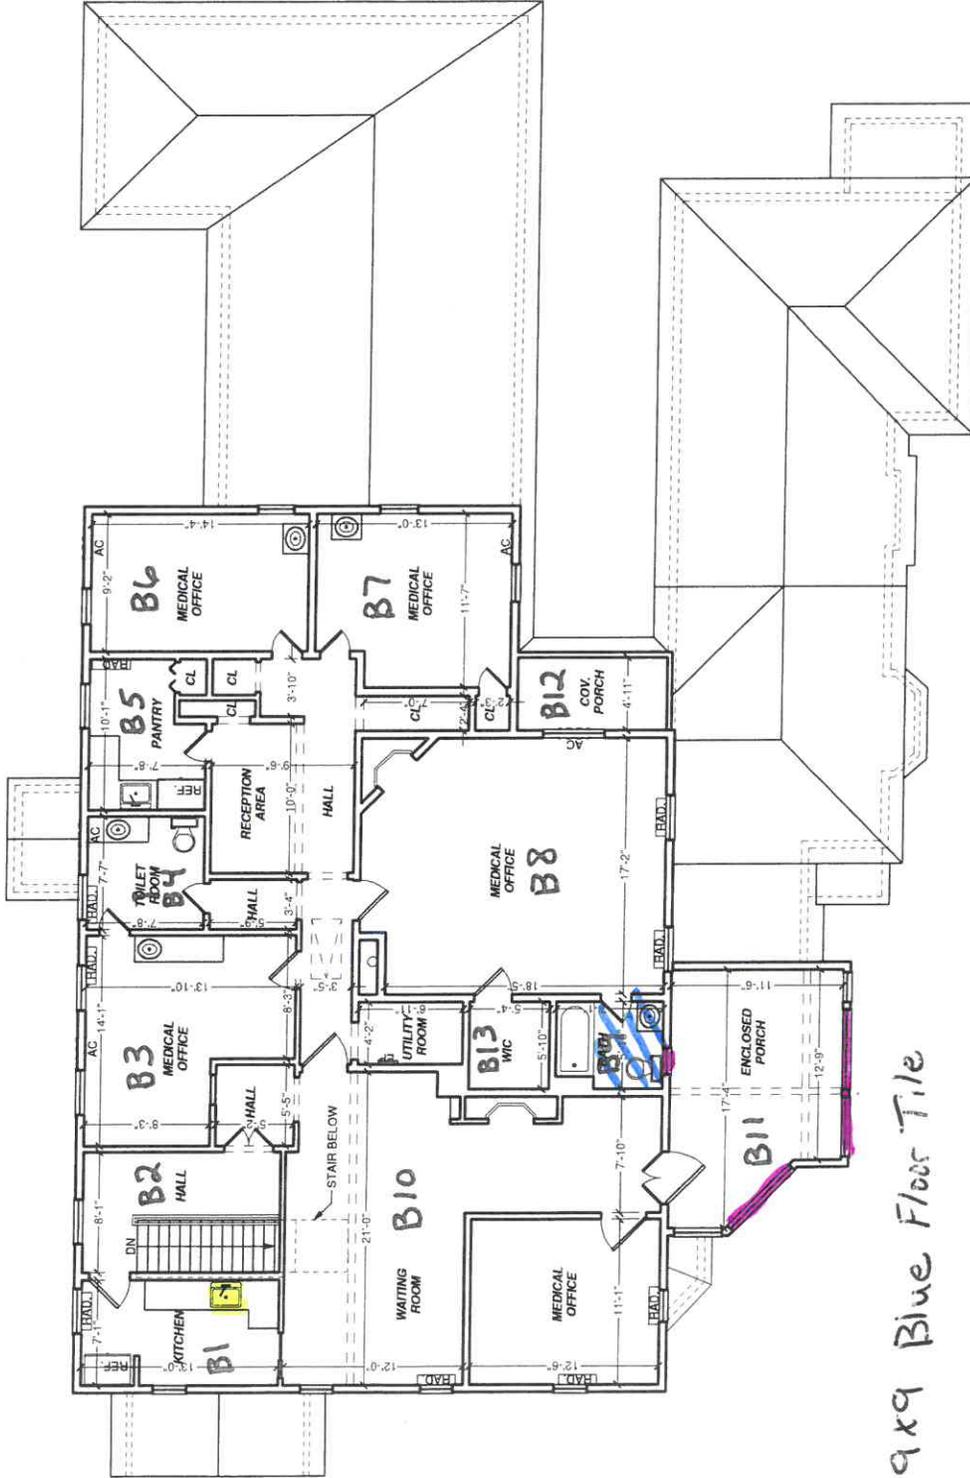
A2.03

■ 9x9 Blue Floor Tile

■ white Sink Undercabinet
