HAZARDOUS MATERIALS SURVEY

Asbestos, Lead-Based Paint and PCB Caulk

*Trudeau Building
118 Main Street
Saranac Lake, New York 12983*

*Survey Dates: July 10, 2018 and April 30, 2021
January 14, 2022*

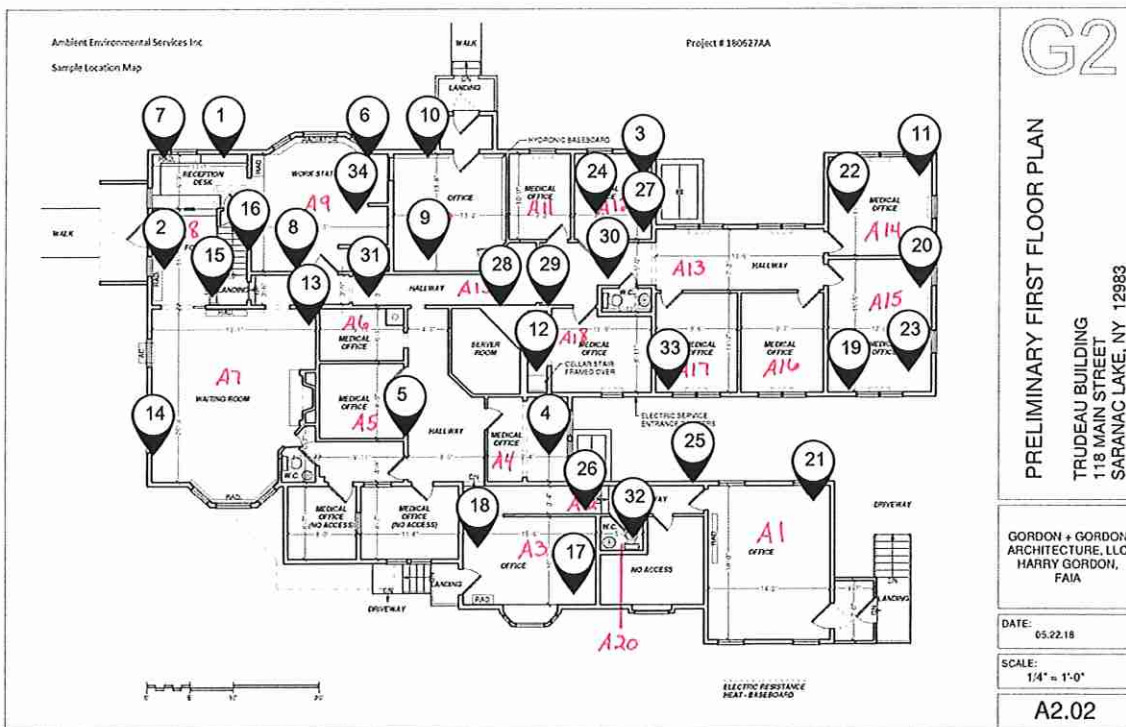
All Sample Locations for First Floor

Map ID	Sample ID	Section Name	Space Name	Material	Lab Result
32	12-01	First Floor	A20	White Speckled Sheet Flooring	NAD
32	13-02	First Floor	A20	Tan Sheet Flooring Adhesive	NAD
33	18-01	First Floor	A8	White Gypsum Wallboard	NAD
33	19-01	First Floor	A17	White Gypsum Wallboard Joint Compound	0.5% Chrysotile
1	28-01	First Floor	A8	Tan Sheet Flooring Burlap Backed	NAD
2	28-02	First Floor	A8	Tan Sheet Flooring Burlap Backed	NAD
7	29-01	First Floor	A8	Pink Swirl Wallpaper	NAD

Map ID	Sample ID	Section Name	Space Name	Material	Lab Result
6	29-02	First Floor	A9	Pink Swirl Wallpaper	NAD
7	30-01	First Floor	A8	Pink Swirl Wallpaper Adhesive	NAD
2	31-01	First Floor	A8	Black Floor Moisture Barrier	NAD
1	31-02	First Floor	A8	Black Floor Moisture Barrier	NAD
1	32-02	First Floor	A8	4"X4" Plum Cove Base	NAD
8	32-02	First Floor	A9	4"X4" Plum Cove Base	NAD
4	33-01	First Floor	A4	Yellow Cove Adhesive	NAD
5	33-02	First Floor	A5	Yellow Cove Adhesive	NAD
4	34-01	First Floor	A4	4"X4" Tan Cove Base	NAD
5	34-02	First Floor	A5	4"X4" Tan Cove Base	NAD
3	35-01	First Floor	A4	Black Sealant, Sink Undercoating	5.8% Chrysotile
4	35-02	First Floor	A4	Black Sealant, Sink Undercoating	NA/PS
1	36-01	First Floor	A8	Tan Cove Adhesive	NAD
8	36-02	First Floor	A9	Tan Cove Adhesive	NAD
9	37-01	First Floor	A10	Tan Woven Wallpaper	NAD
10	37-02	First Floor	A10	Tan Woven Wallpaper	NAD
10	38-01	First Floor	A10	Yellow (Woven) Wallpaper Adhesive	Insufficient Material for Preparation

Map ID	Sample ID	Section Name	Space Name	Material	Lab Result
20	48-02	First Floor	A15	Small Stone Floor, Sheet Vinyl Paper Backing	NAD
21	49-01	First Floor	A1	Black Floor Moisture Barrier	NAD
21	49-02	First Floor	A1	Black Floor Moisture Barrier	NAD
23	50-01	First Floor	A15	1'X1' White Pinhole Ceiling Tile, Splined	NAD
22	50-02	First Floor	A14	1'X1' White Pinhole Ceiling Tile, Splined	NAD
24	51-01	First Floor	A12	2'x2' White Wormtrack Ceiling Tile, Lay In	NAD
24	51-02	First Floor	A12	2'x2' White Wormtrack Ceiling Tile, Lay In	NAD
21	52-01	First Floor	A1	Light Tan Sheet Flooring Burlap Backed	NAD
21	52-02	First Floor	A1	Light Tan Sheet Flooring Burlap Backed	NAD
23	53-01	First Floor	A15	1'X1' Tan (Pinhole) Ceiling Tile Adhesive	Anthophyllite Trace
22	53-02	First Floor	A14	1'X1' Tan (Pinhole) Ceiling Tile Adhesive	Anthophyllite Trace
25	54-01	First Floor	A2	4'x8' White Grooved Gypsum Wallboard	NAD
26	54-02	First Floor	A2	4'x8' White Grooved Gypsum Wallboard	NAD

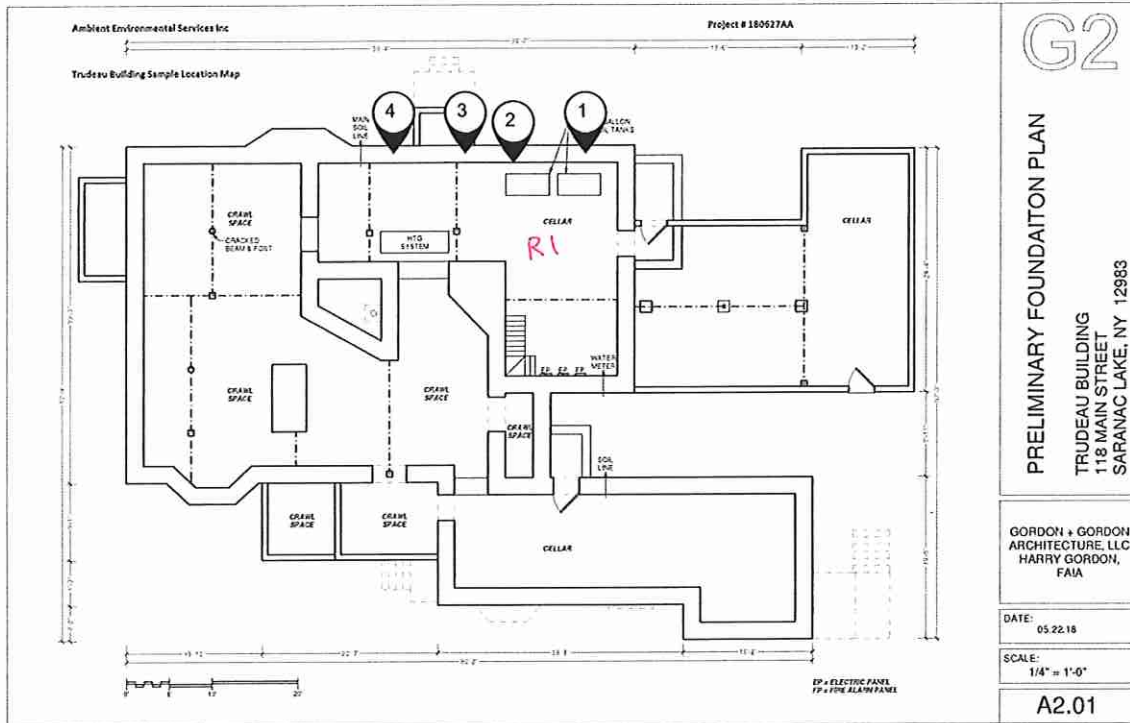
All Sample Locations for Basement

Map ID	Sample ID	Section Name	Space Name	Material	Lab Result
1	57-01	Basement	R1	Gray Pipe Insulation, Corrugated	44.4% Chrysotile
2	57-02	Basement	R1	Gray Pipe Insulation, Corrugated	NA/PS
1	57-03	Basement	R1	Gray Pipe Insulation, Corrugated	NA/PS
3	58-01	Basement	R1	Gray Stone Masonry Mortar	NAD
4	58-02	Basement	R1	Gray Stone Masonry Mortar	NAD

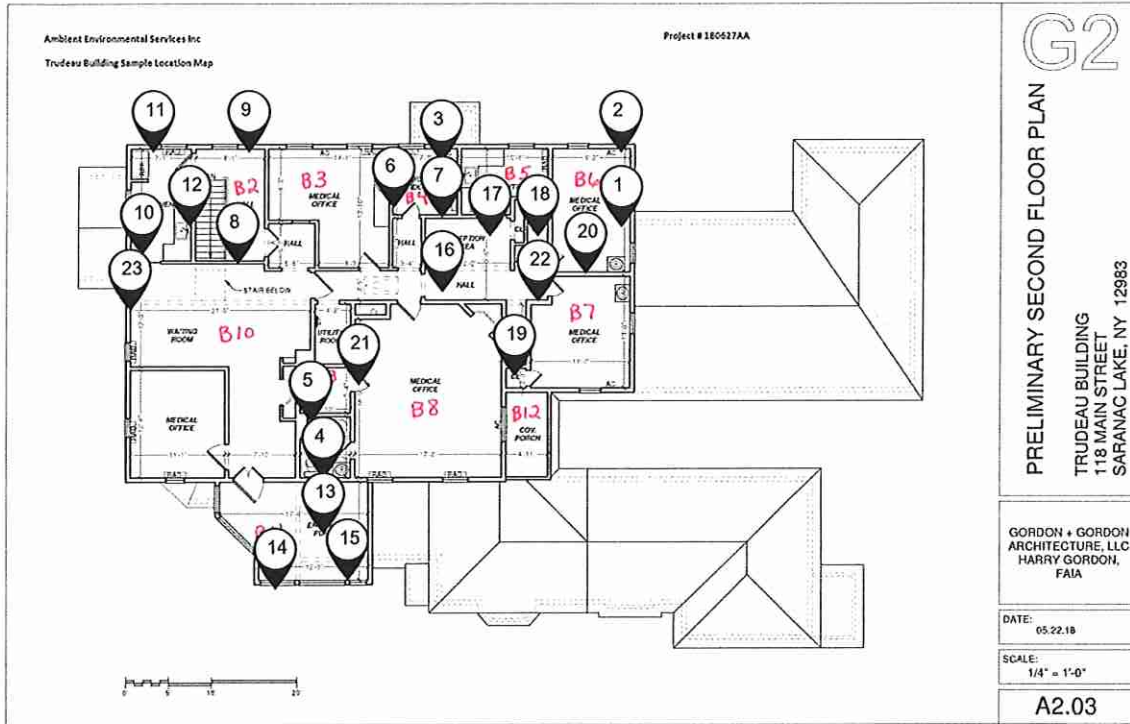
All Sample Locations for Second Floor

Map ID	Sample ID	Section Name	Space Name	Material	Lab Result
21	01-01	Second Floor	B8	White Acoustical Plaster, Ceilings	NAD
19	01-02	Second Floor	B7	White Acoustical Plaster, Ceilings	NAD
20	01-03	Second Floor	B6	White Acoustical Plaster, Ceilings	NAD
22	02-01	Second Floor	B6	White Acoustical Plaster, Walls	NAD
23	02-02	Second Floor	B10	White Acoustical Plaster, Walls	NAD
22	02-03	Second Floor	B13	White Acoustical Plaster, Walls	NAD
16	03-01	Second Floor	B13	2'x4' White Worm Track Ceiling Tile, Lay In	NAD
17	03-02	Second Floor	B13	2'x4' White Worm Track Ceiling Tile, Lay In	NAD
3	04-01	Second Floor	B4	Gray Cove Base	NAD
7	04-02	Second Floor	B4	Gray Cove Base	NAD
3	05-01	Second Floor	B4	White Cove Adhesive	NAD
3	05-02	Second Floor	B4	White Cove Adhesive	NAD

Map ID	Sample ID	Section Name	Space Name	Material	Lab Result
1	06-01	Second Floor	B6	Blue Floral Wallpaper	NAD
2	06-02	Second Floor	B6	Blue Floral Wallpaper	NAD
1	07-01	Second Floor	B6	Blue Floral Wallpaper Adhesive	NAD
2	07-02	Second Floor	B6	Blue Floral Wallpaper Adhesive	NAD
5	08-01	Second Floor	B7	4"X4" Tan Tile Adhesive	NAD
5	08-02	Second Floor	B7	4"X4" Tan Tile Adhesive	NAD
7	10-01	Second Floor	B4	Tan Tree Wallpaper	NAD
7	10-02	Second Floor	B4	Tan Tree Wallpaper	NAD
7	11-01	Second Floor	B4	Tan Tree Wallpaper Adhesive	NAD
7	11-02	Second Floor	B4	Tan Tree Wallpaper Adhesive	NAD
3	12-02	Second Floor	B4	White Speckled Sheet Flooring	NAD
3	13-01	Second Floor	B4	Tan Sheet Flooring Adhesive	NAD
3	14-01	Second Floor	B4	Green Woven Wallpaper	NAD
3	14-02	Second Floor	B4	Green Woven Wallpaper	NAD
3	15-01	Second Floor	B4	Green Woven Wallpaper Adhesive	NAD
6	15-02	Second Floor	B4	Green Woven Wallpaper Adhesive	NAD

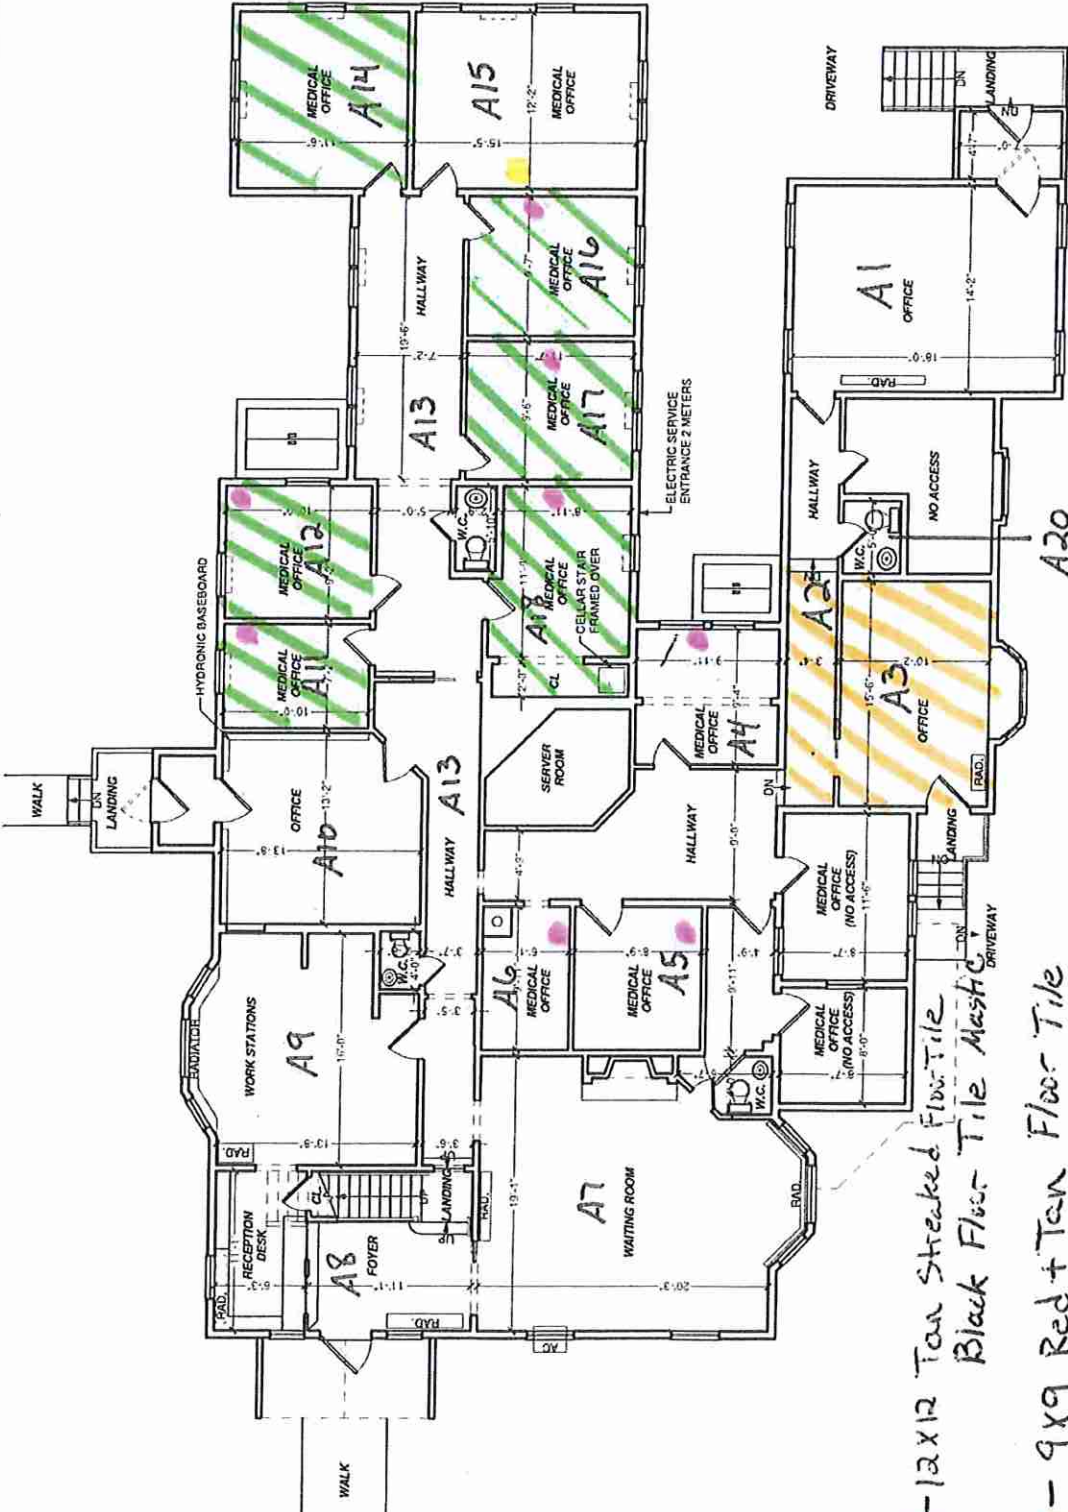
Material Location Map | 5+ Floor

- 12x12 Tan Streaked Floor Tile
- 9x9 Red + Tan Floor Tile
- Black Vapor Barrier / Floor Tile Mastic
- Black Sink Undercoating
- white Sink Undercoating

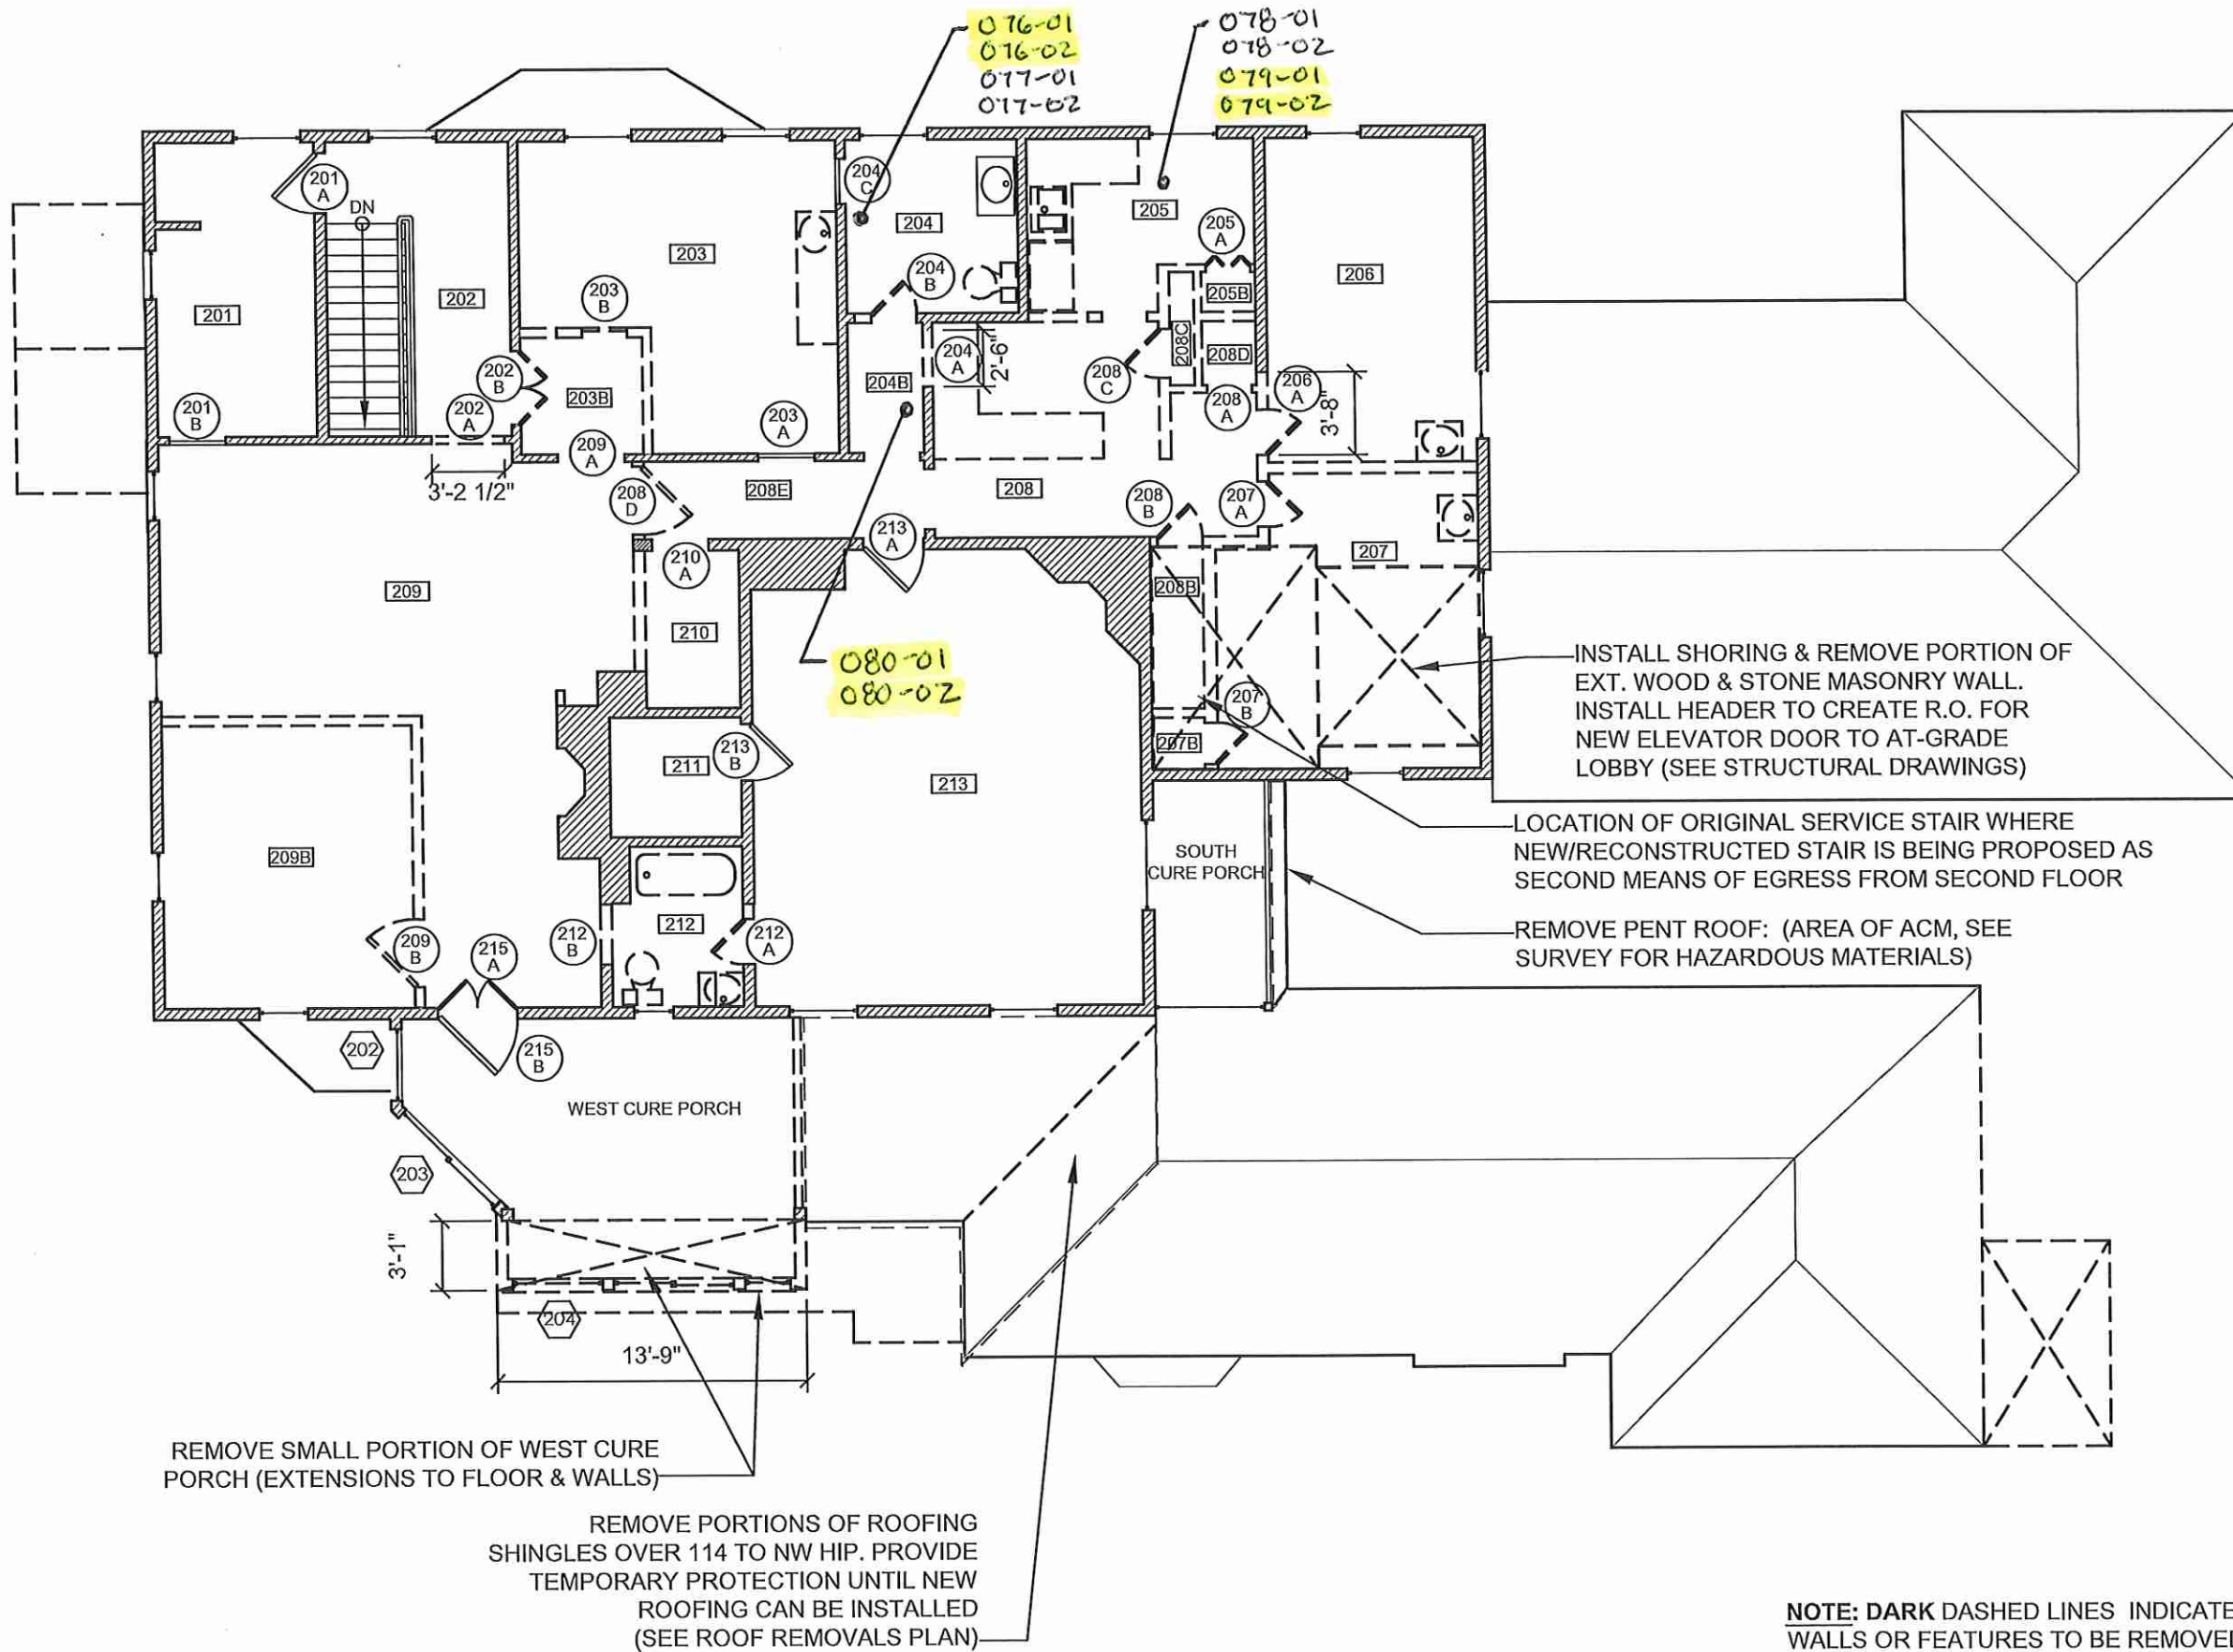
REMOVE PENT ROOF: (AREA OF ACM, SEE SURVEY FOR HAZARDOUS MATERIALS)

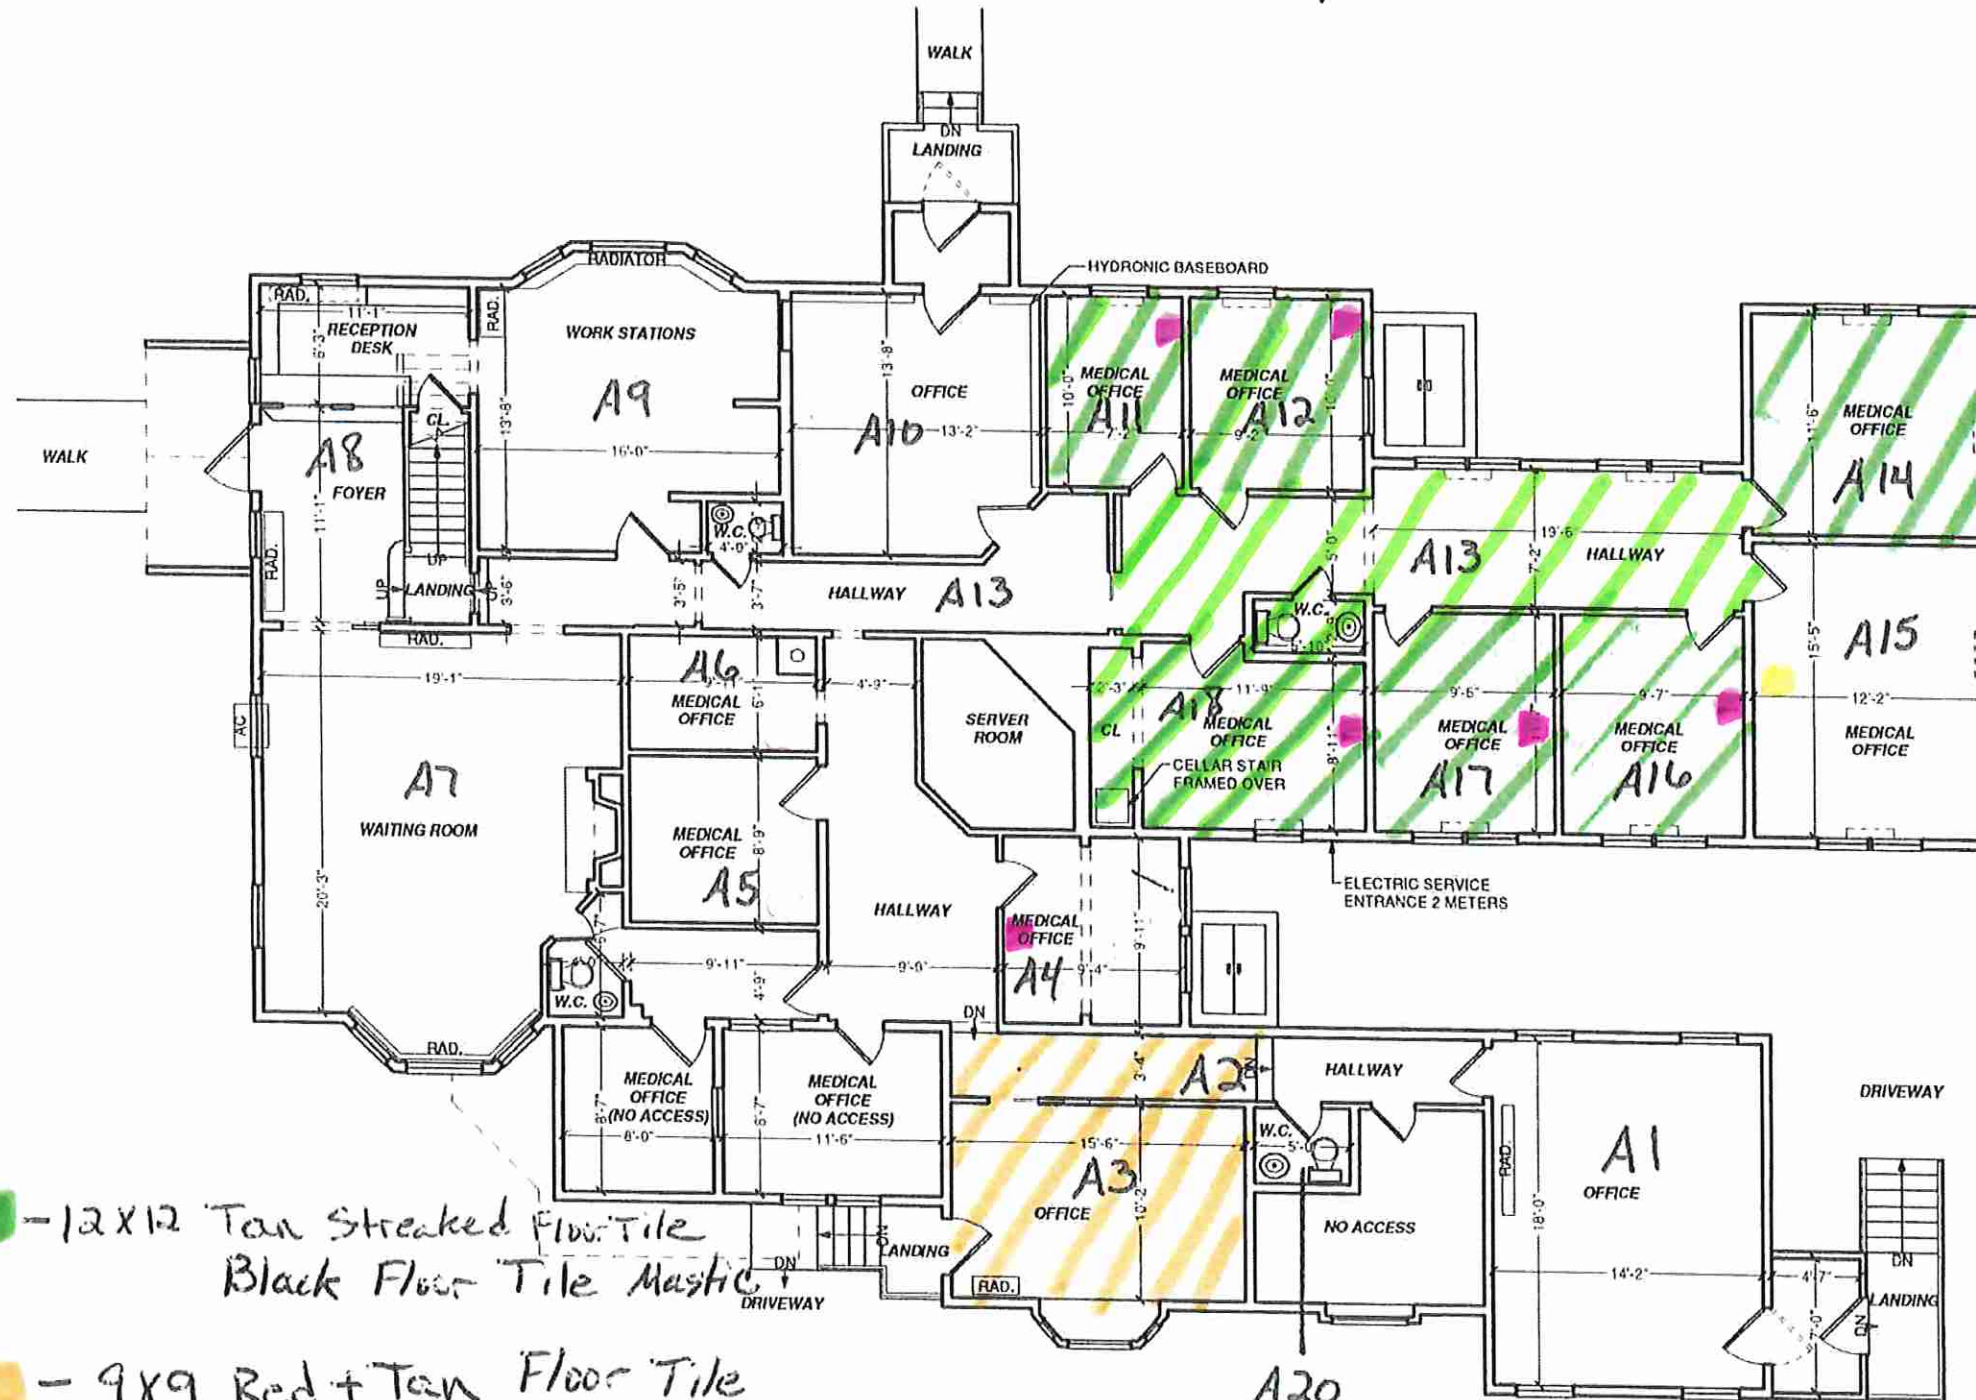
Material Location Map 1st Floor - REVISED 01/14/2022

- 12x12 Tan Streaked Floor Tile
Black Floor Tile Mastic
- 9x9 Red + Tan Floor Tile
Black Vapor Barrier / Floor Tile Mastic
- Black Sink Undercoating
- White Sink Undercoating
