Dr. E. L. Trudeau Building
118 Main Street
Saranac Lake NY

Historic Building Evaluation
Structural Conditions Requiring Remediation
Gordon + Gordon Architecture, LLC
June 24, 2018

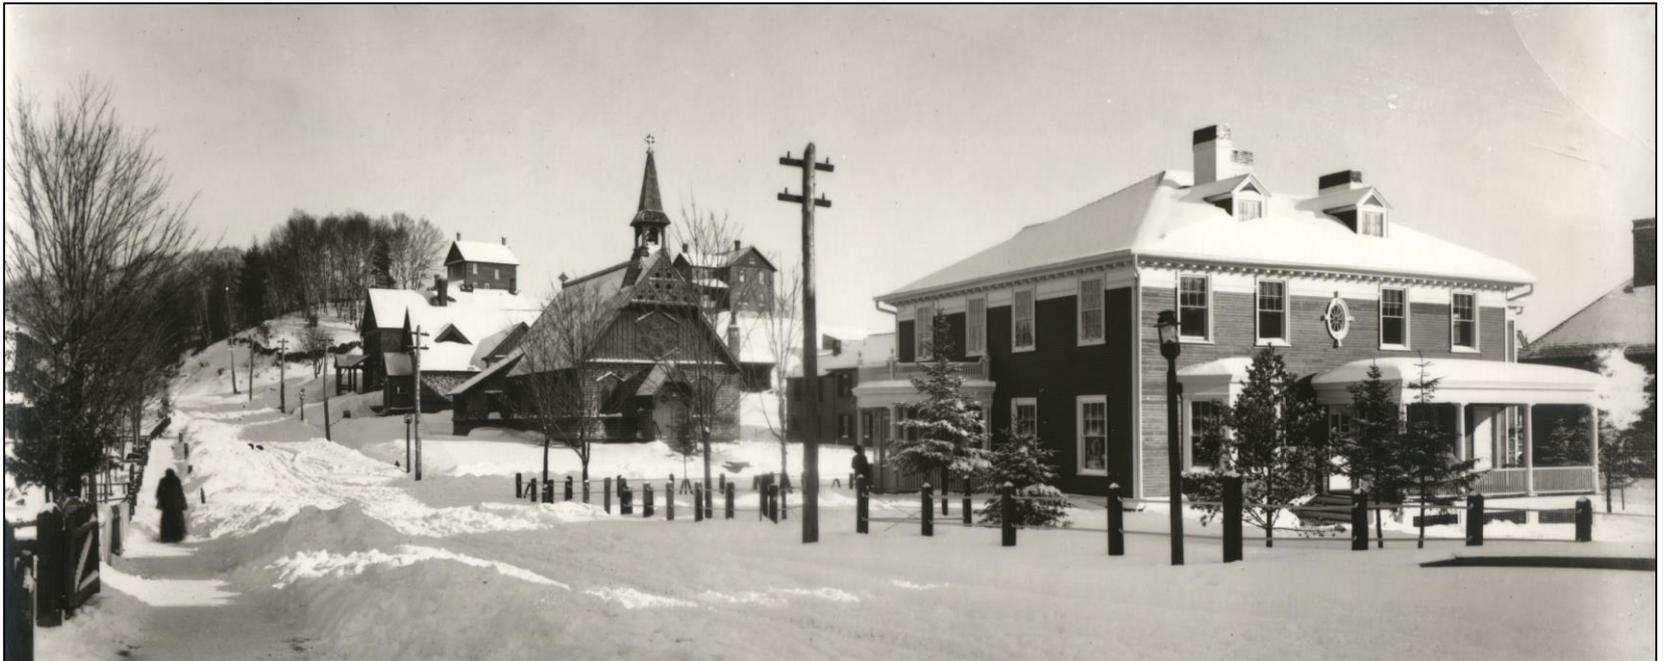
The original portion of the building was constructed at the corner of Main and Church Streets. The stone foundation encloses a combination of cellar and crawl space conditions. The first floor structure under the crawl space portion of the building exhibits some significant structural deterioration.

The main structure of the first floor consists of heavy timber beams and columns supporting wood floor joists. Longitudinal cracking was observed in some of the timber beams. There is also some evidence of water damage. Some work has been done in the past to provide additional support.
