HAZARDOUS MATERIALS SURVEY

Asbestos, Lead-Based Paint and PCB Caulk

*Trudeau Building
118 Main Street
Saranac Lake, New York 12983*

*Survey Dates: July 10, 2018 and April 30, 2021
January 14, 2022*

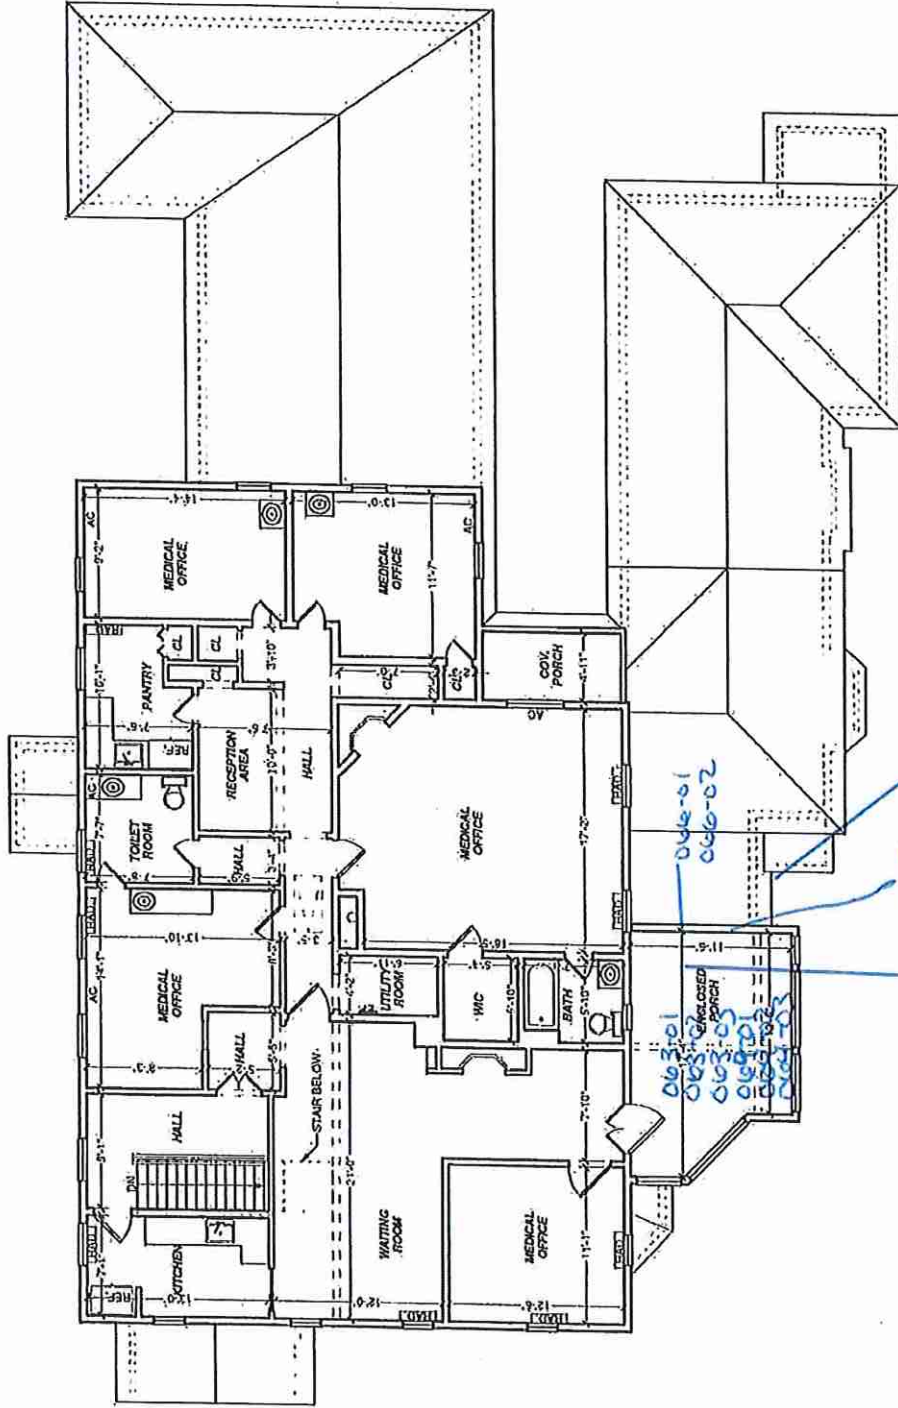
Sample location drawing
XXX-XX = positive watered

- 063-01
- 063-02
- 063-03
- 063-04
- 063-05
- 063-06
- 065-01
- 065-02
- 065-03
- 065-04
- 065-05
- 067-01
- 067-02
- 067-03
- 067-04
- 067-05
- 067-06

Material location drawing
 A = Acn Bottom layer Vapor Barrier
 upper level porch roof
